Exploring MapSwipe as a Crowdsourcing Tool for (Rapid) Damage Assessment: The Case of the 2021 Haiti Earthquake

Abstract. Fast and reliable geographic information is vital in disaster management. In the late 2000s, crowdsourcing emerged as a powerful method to provide this information. Base mapping through crowdsourcing is already well-established in relief workflows. However, crowdsourced post-disaster damage assessment is researched but not yet institutionalized. Based on MapSwipe, an established mobile application for crowdsourced base mapping, a damage assessment approach was developed and tested for a case study after the 2021 Haiti earthquake. First, MapSwipe's damage mapping results are assessed for quality by using a reference dataset in regard to different aggregation methods. Then, the MapSwipe data was compared to an already established rapid damage assessment method by the Copernicus Emergency Management Service (CEMS). Crowdsourced building damage mapping achieved a maximum F1-score of 0.63 in comparison to the reference data set. MapSwipe and CEMS data showed only slight agreement with Cohen's Kappa values reaching a maximum of 0.16. The results highlight the potenti

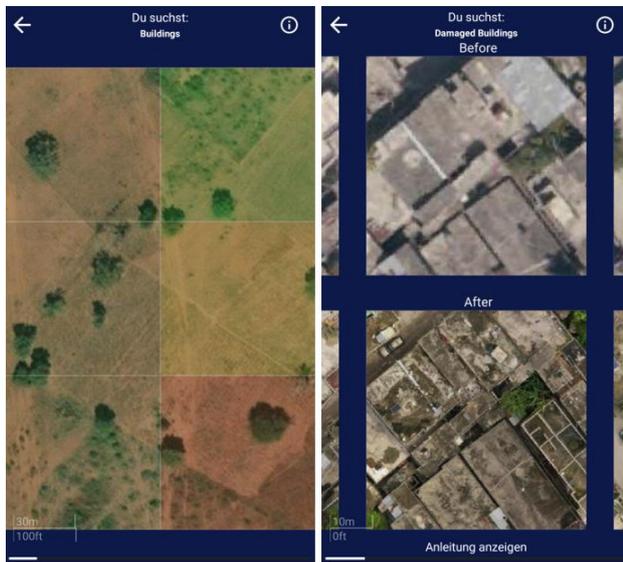
Figure 2. Different MapSwipe interfaces. **Left:** Original base mapping interface for MapSwipe with six tiles, green for "building", yellow for "maybe", red for "bad imagery" and no color for "no building". **Right:** Damage assessment interface with before picture on the top and after picture on the bottom. The single tile can be marked with the same colors, except that "building" means "damaged".

MapSwipe's default change detection project type, which was used here to assess damage, is based on the tile level. For this project type, instead of only looking at six tiles at once (see MapSwipe's original project type Figure 2 left), users now compare a pair of satellite or aerial imagery tiles (Figure 2 right). Both tiles depict the same area, the upper tile shows the situation before the earthquake and the second tile shows the situation after the earthquake. In our case, the before image is an orthophoto from Haiti's open data portal (HaitiData, 2021) with an unknown resolution and the after image can be found on OpenAerialMap (Gastaminza, 2021) with an original resolution of 2 cm. The volunteers can then decide if buildings inside the respective tile have been damaged. For this study, a tile corresponded to the definition applied by tile map services (TMS) at zoom level 20 (Maso et al., 2010). The respective edge lengths for the tiles are ~ 40 Meters, that gives the pictures a maximum resolution of 15.6 cm in the app (initial resolution of the drone imagery was 2 cm). In total, the entire project area was covered by 1,806 mapping tasks.

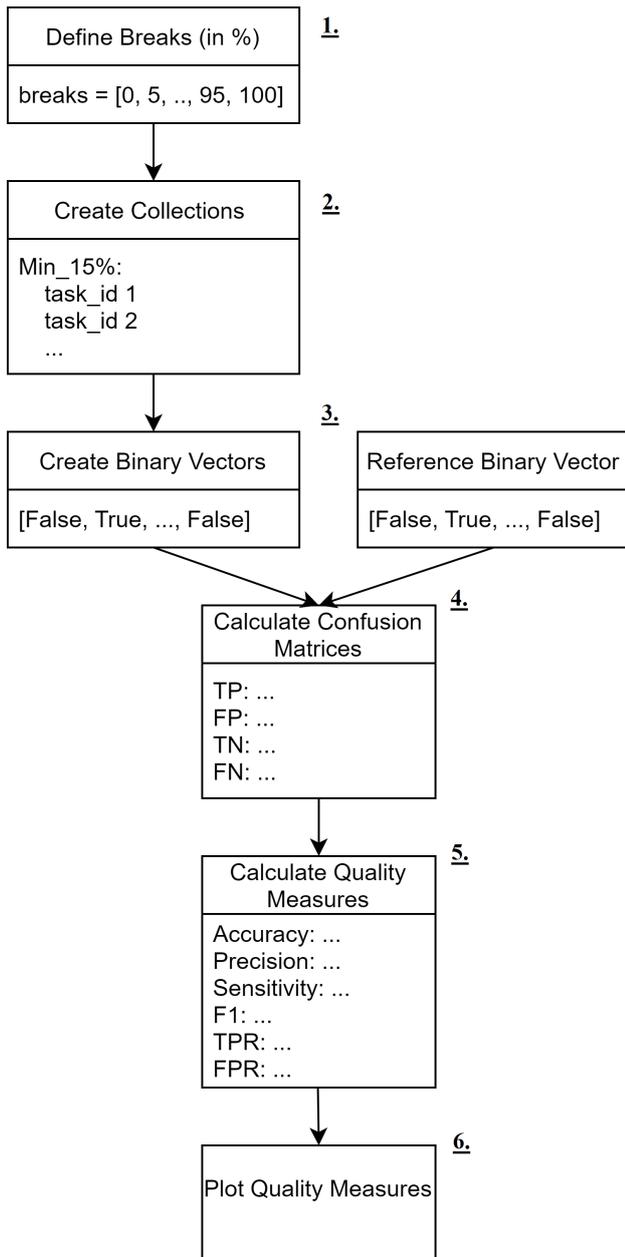
Figure 3. Workflow diagram for quality assessment (RQ1): 1. Define step granularity 2. Create collection for each step 3. Create binary vectors for the collections and the reference dataset 4. Calculate confusion matrices for each collection 5. Derive quality measures 6. Visualization.

In crowdsourcing approaches which rely on redundant classification there is a particular importance to define the "correct" threshold when aggregating the contributions of individual users into a consensus answer (de Albuquerque et al., 2016). To account for this, different thresholds and their effect on data quality have been explored in this study. A threshold describes the share of volunteers that tag a tile as damaged. So if 5, 10, ..., 95 percent of the users tagged a tile as damaged it will be classified as damaged. By choosing a threshold-based approach we aim at a good balance between precision and sensitivity. Based on these aggregated MapSwipe results and the reference dataset (see 2.2.3), we used the scikit-learn library for Python to create a confusion matrix. This returns the True Positives (TP), True Negatives (TN), False Positives (FP) and False Negatives (FN) and calculates the True Positive Rate (TPR) and False Positive Rate (FPR), further described in Table 2. These values are then used to calculate different data quality measures: accuracy, precision, sensitivity (same as TPR) and the F1-score, also described in Table 2. The detailed workflow is depicted in Figure 3.

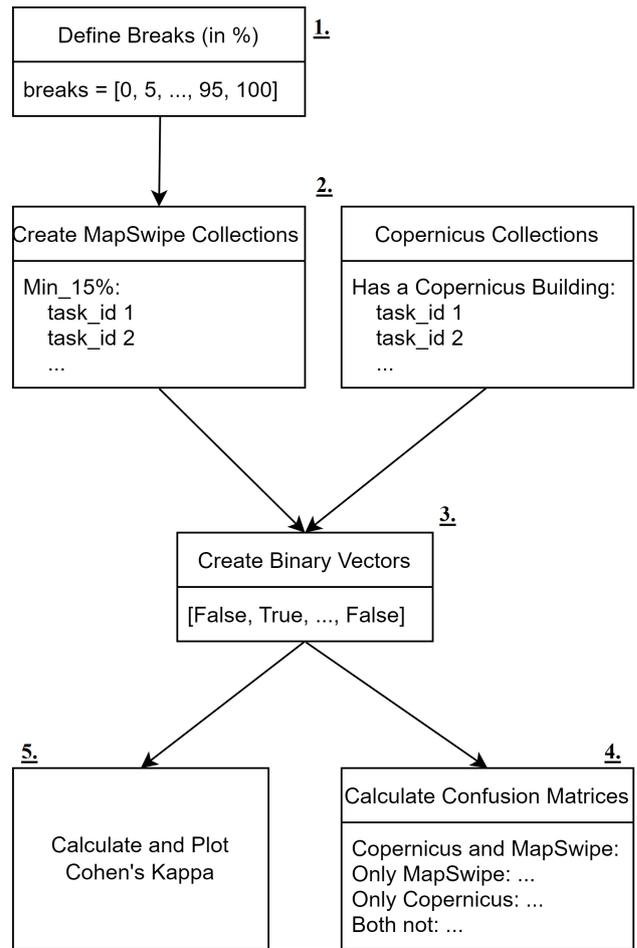
Figure 4. Workflow diagram for comparison with Copernicus data (RQ2): 1. Define step granularity 2. Create collections for each step and for Copernicus buildings 3. Create binary vectors for each collection 4. Calculate confusion matrices for each collection 5. Calculate Kappa and Visualization.

Agreement analyses conducted between MapSwipe and Copernicus data were accomplished using confusion matrices based on the MapSwipe tiles and Copernicus buildings footprints. Again, the whole workflow is depicted in Figure 4.

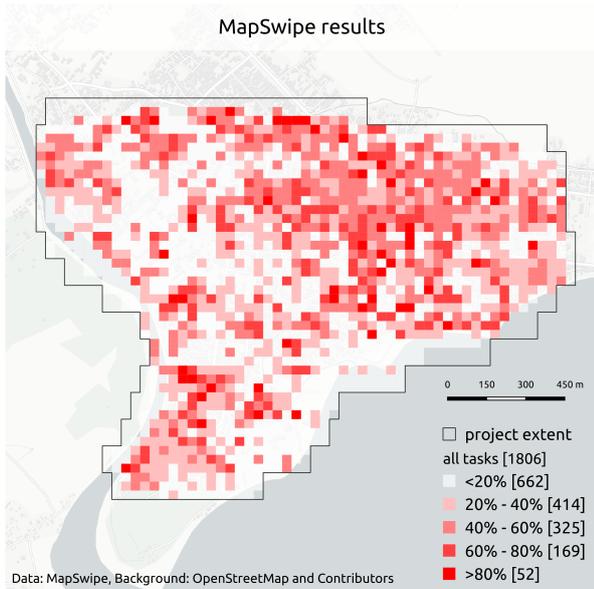
Figure 5. MapSwipe aggregated results for damage assessment. Percentages correspond to the share of volunteers that tagged the respective tile as damaged.

Figure 5 shows the aggregated MapSwipe results and the spatial distribution of tasks for which MapSwipe users identified damaged buildings. The map provides a first visual impression that damage buildings in Les Cayes were primarily located in the eastern part of the study area.

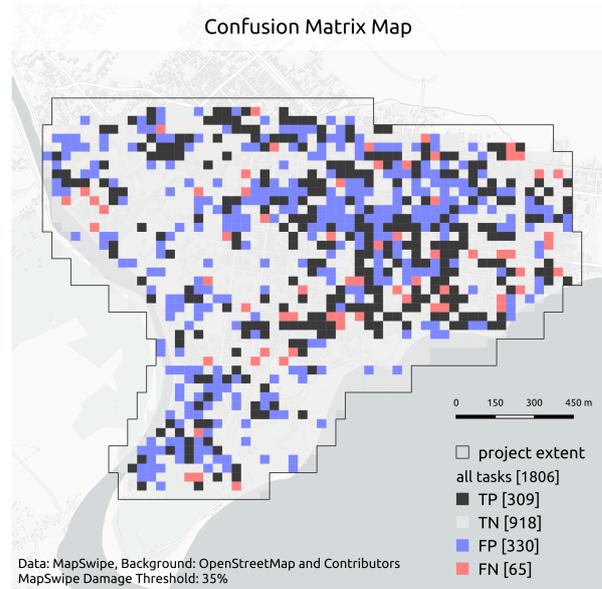
Figure 7. Spatial distribution of false positives, true positives, false negatives and true negatives considering a threshold $\geq 35\%$.

Figure 7 shows the confusion matrix in a spatial context.

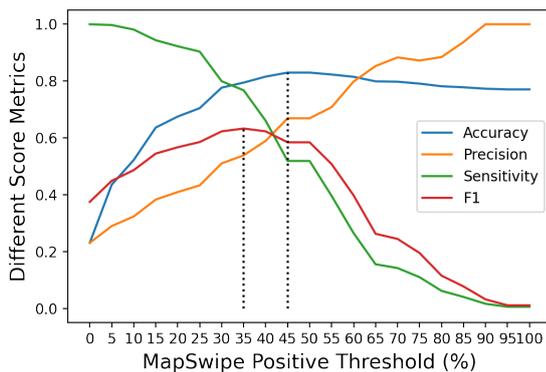
Figure 6. Quality parameters for different damage definition thresholds for MS-small. F1 peaks with sensitivity above precision. The accuracy high level for greater thresholds indicates its weaknesses in this context.

Figure 6 shows the MapSwipe threshold definitions plotted against the four different quality measures. Precision rises with a higher threshold since it is more likely for damaged labels to be correct with a higher threshold, and sensitivity falls since more and more damaged tiles are overlooked. Accuracy rises until a threshold of 45 percent (0.83) and then, after a slight fall, stays about the same until the end. This illustrates the weakness for accuracy as a quality measure, since with high thresholds the high amount of TNs overshadow the FNs. Therefore, the F1-score is the better indicator here. It peaks at a threshold

of 35 percent (0.63) but only differs slightly at 30 or 40 percent (both 0.62). Based on this, simply relying on majority voting is not enough for this use case, since better results can be achieved setting the threshold lower than 50 percent. For the case of Les Cayes our results show that the aggregated result should be classified as "damage" if at least 35 percent of the individual raters identified damage in the aerial imagery.

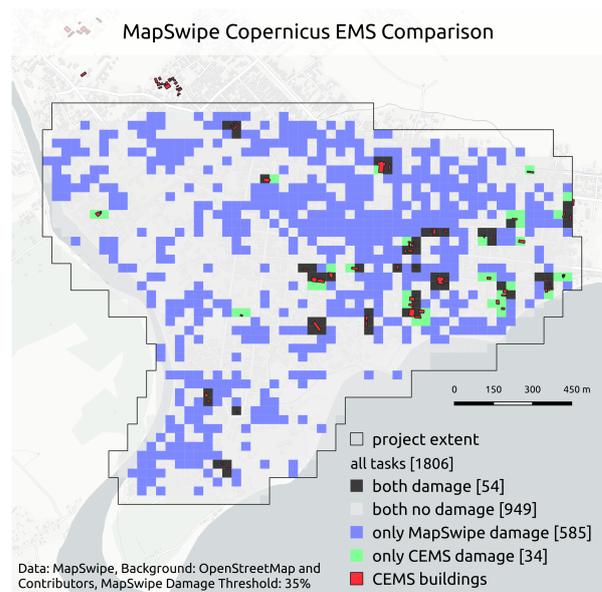
Figure 8. Spatial distribution of agreement between MapSwipe results and CEMS results, considering a threshold $\geq 35\%$.

After exploring how MapSwipe data performs, it can be compared to CEMS data. Figure 8 provides an overview for which tasks both approaches detected damage (54 tasks in total). Furthermore there were 34 tasks for which only CEMS detected damaged buildings, whereas there were 586 tasks for which damage was detected by MapSwipe users, but not CEMS. This might already suggest, that minor damage that was overlooked by CEMS, could be identified on the MapSwipe pictures due to the increased imagery resolution.

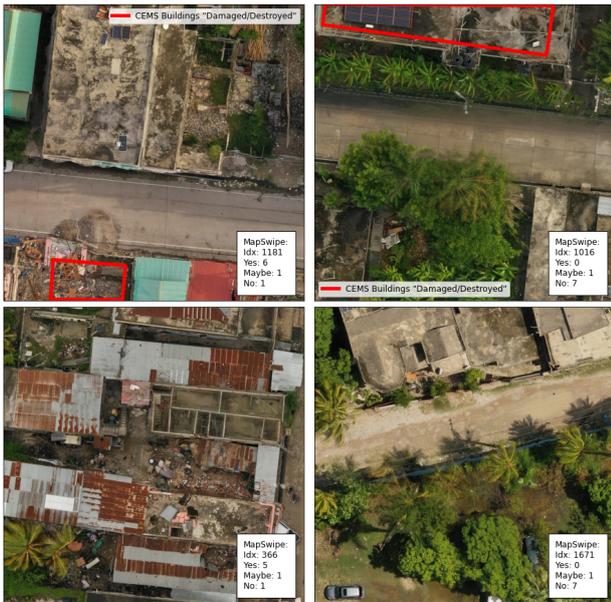
Figure 9. Example tiles to assess agreement between Copernicus and MapSwipe. The white box gives information about the MapSwipe answers. **Top-left:** Tagged as damaged by MapSwipe and Copernicus. **Top-right:** Only tagged by Copernicus. **Bottom-left:** Only tagged by MapSwipe. **Bottom-right:** Not tagged by both.

Examples of this confusion matrix' cells are depicted in Figure 9 with the respective MapSwipe answers. In the first picture, both MapSwipe and CEMS found a destroyed building. It is however still unclear if all MapSwipe users tagged the picture because of the destroyed building at the bottom or because of the debris on the top-right. The second picture is almost unanimously tagged without damage in MapSwipe, Copernicus may have found damaged here

on the day after the event that is not recognizable anymore after ten days, when the MapSwipe image was taken, or it was a false positive tag. The third picture shows an example where there is clearly damage visible and it is tagged by the volunteers. However, CEMS could not find this one, maybe due to the worse resolution. On the fourth picture in both cases no damage could be found.

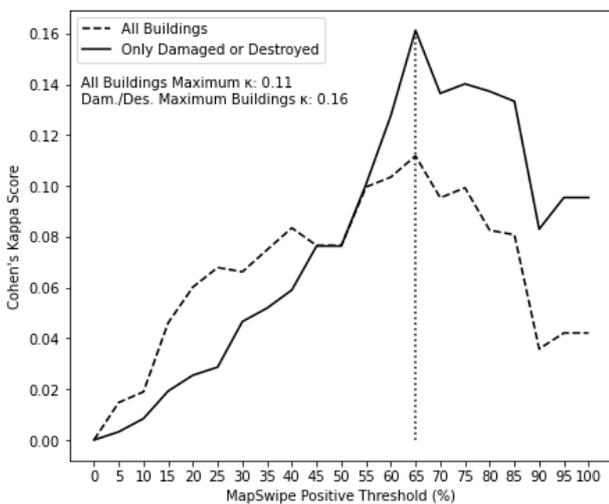
Figure 10. Cohen's Kappas between MapSwipe and CEMS labels by damage definition threshold. In both cases Kappa peaks at a threshold value of 65%. Agreement is very low, which could be explained by different picture acquisition times and resolutions. For the MapSwipe threshold with maximum F1-score (35%) Kappa values are 0.075 and 0.052 for all and damaged/destroyed buildings.

Cohen's Kappa was plotted with different thresholds for a positive definition in MapSwipe compared to the damaged buildings tagged by CEMS (Figure 10). The dashed line represents all CEMS tagged buildings, the solid line only the CEMS buildings tagged as "damaged" or "destroyed" (excluding "possibly damaged" buildings). In both cases Kappa is almost monotonically increasing until 65 percent

and then decreasing. That means that in order to reach maximum agreement with Copernicus data, 65 percent of users have to declare a tile damaged. Compared with the results from the quality assessment, the MapSwipe threshold has to be defined much stricter.

Kappa itself is astoundingly low, with only slight agreement in all relevant cases. That suggests, that generally CEMS data, and MapSwipe data do not compare well. When ignoring possibly damaged buildings in CEMS
